Technical Note N-1148

AIRFIELD PAVEMENT CONDITION SURVEY,  
USNAS POINT MUGU, CALIFORNIA

D. J. Lambiotte and R. B. Brownie

February 1971

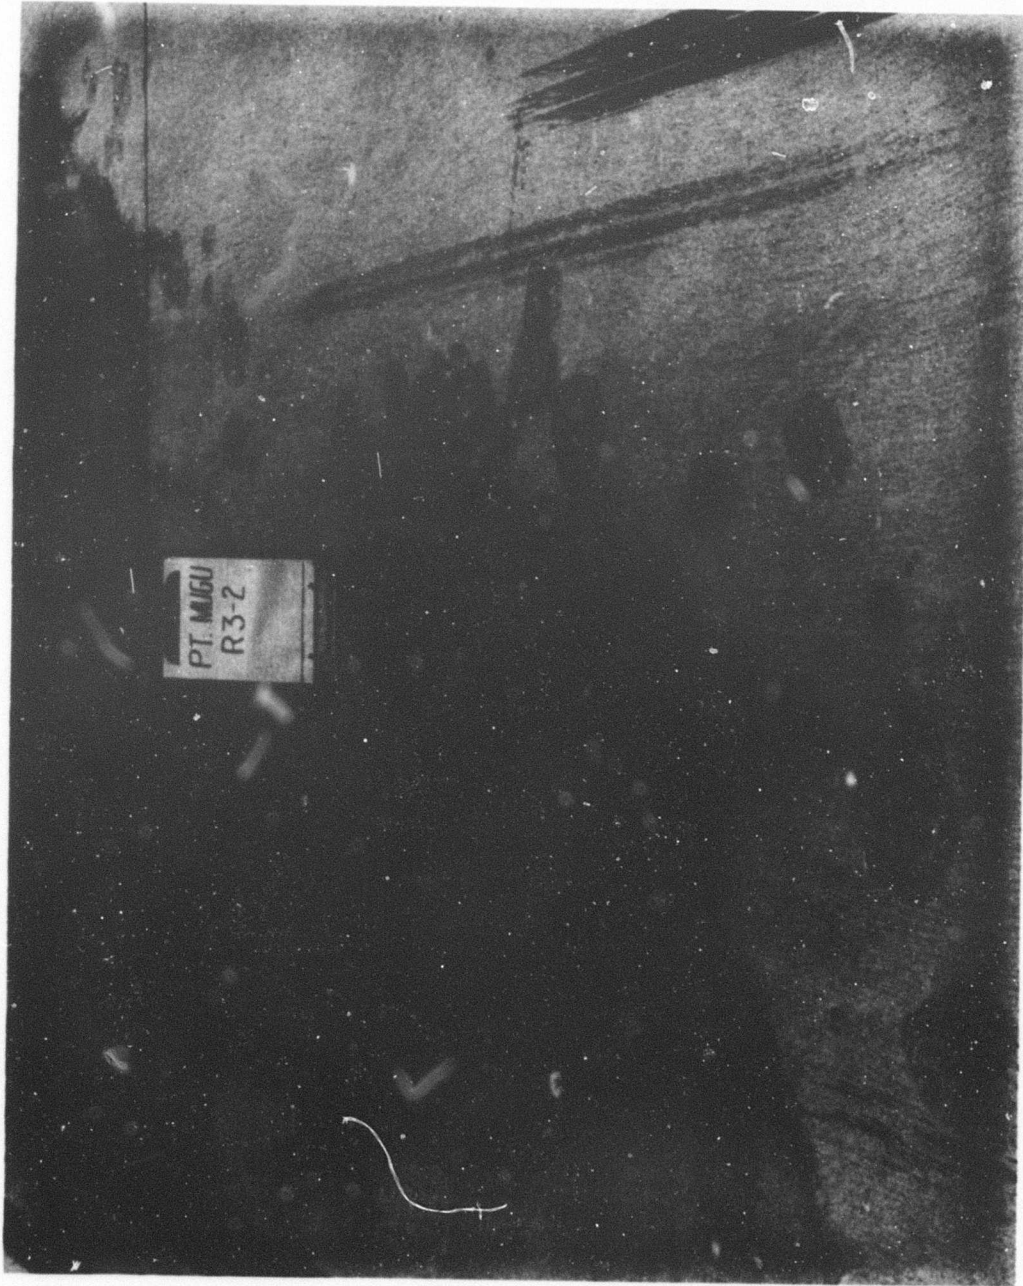
Figure 5. Repaired jet blast spalls, discrete area R3-2.

Spalls were up to 6 inches wide and some contained loose chunks. The joint seal was hardened and occasionally was missing in strips up to 2 feet long. Severe surface spalling due to jet blast had taken place at the west end of the runway. Approximately 95% of the surface spalls were repaired. See Figure 5.

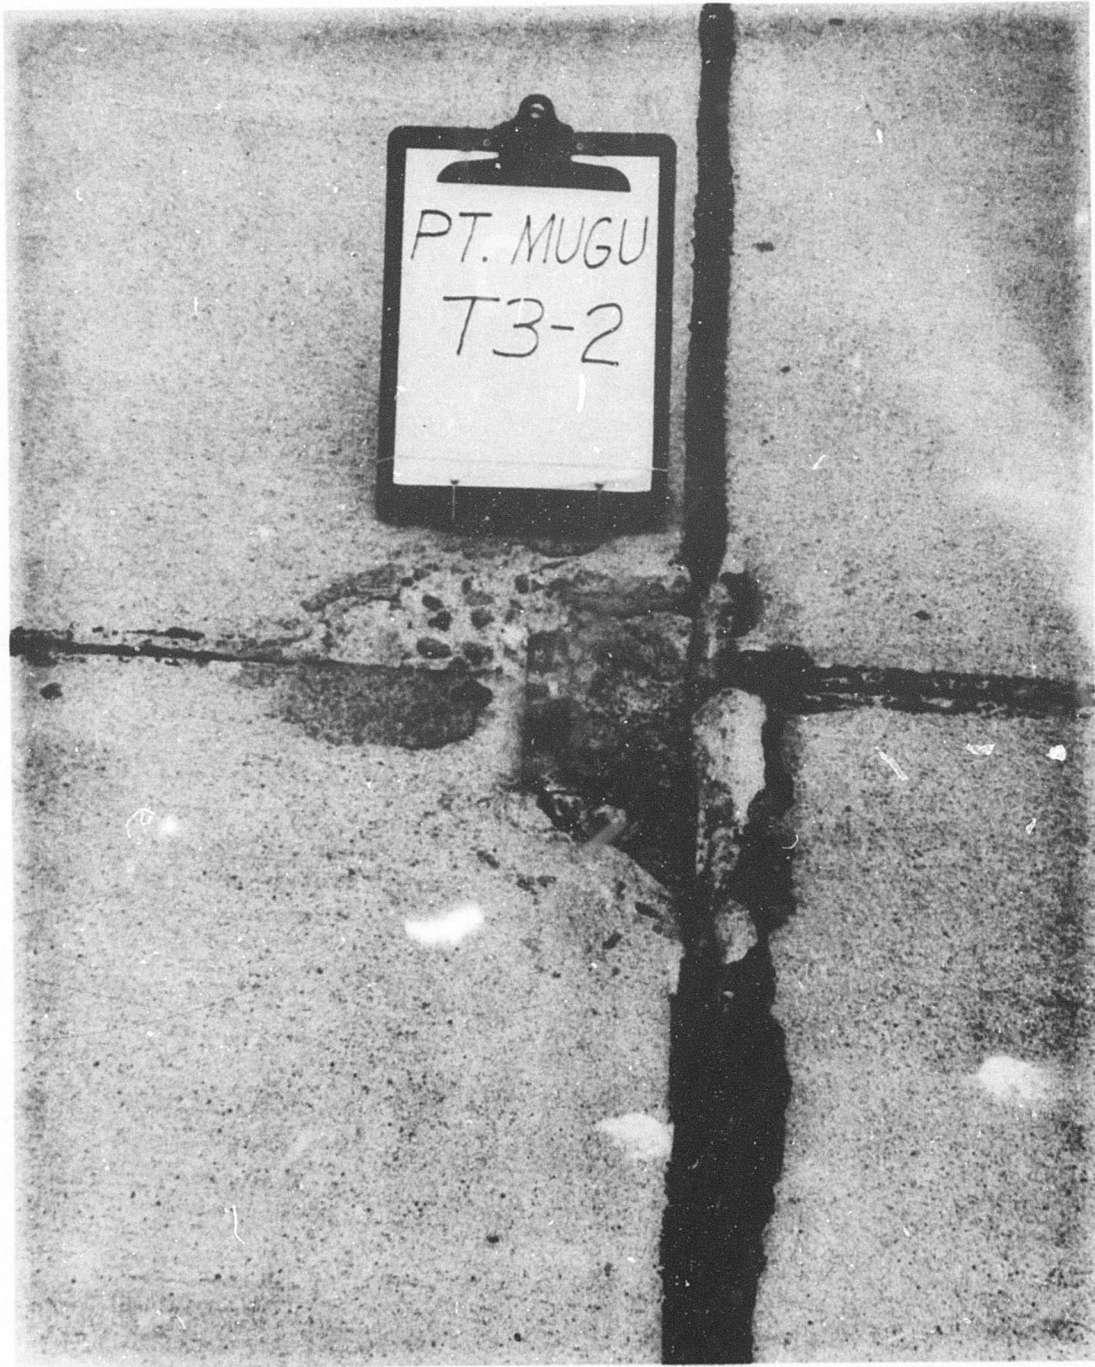
Figure 6. Failed corner spall repair, discrete area T3-2.

Defect Type	No. of Sample Slabs w/Defect	Total Slabs w/Defect: c x a/b	Defect Density (per slab) d/a	Defect Severity Weight	Weighted Defect Density e x f
	(c)	(d)	(e)	(f)	(g)
Faulting					
Corner Break					
L.C. or T.C.*					
I.C.**					
Depression					
Spalling	5	20	0.152	7.5	1.14
Scaling					
Shattered Slab					
Joint Seal	33	132	1.000	2.5	2.50
Pumping					
"D-line" cracking					
Remarks on Pavement Condition					Total 3.64C ***
Spalls occurred primarily on corners and transverse expansion joints. Spalls were up to 8 inches wide and exhibited loose material. Joint seal was shriveled and had lost bond. See Figure 6.

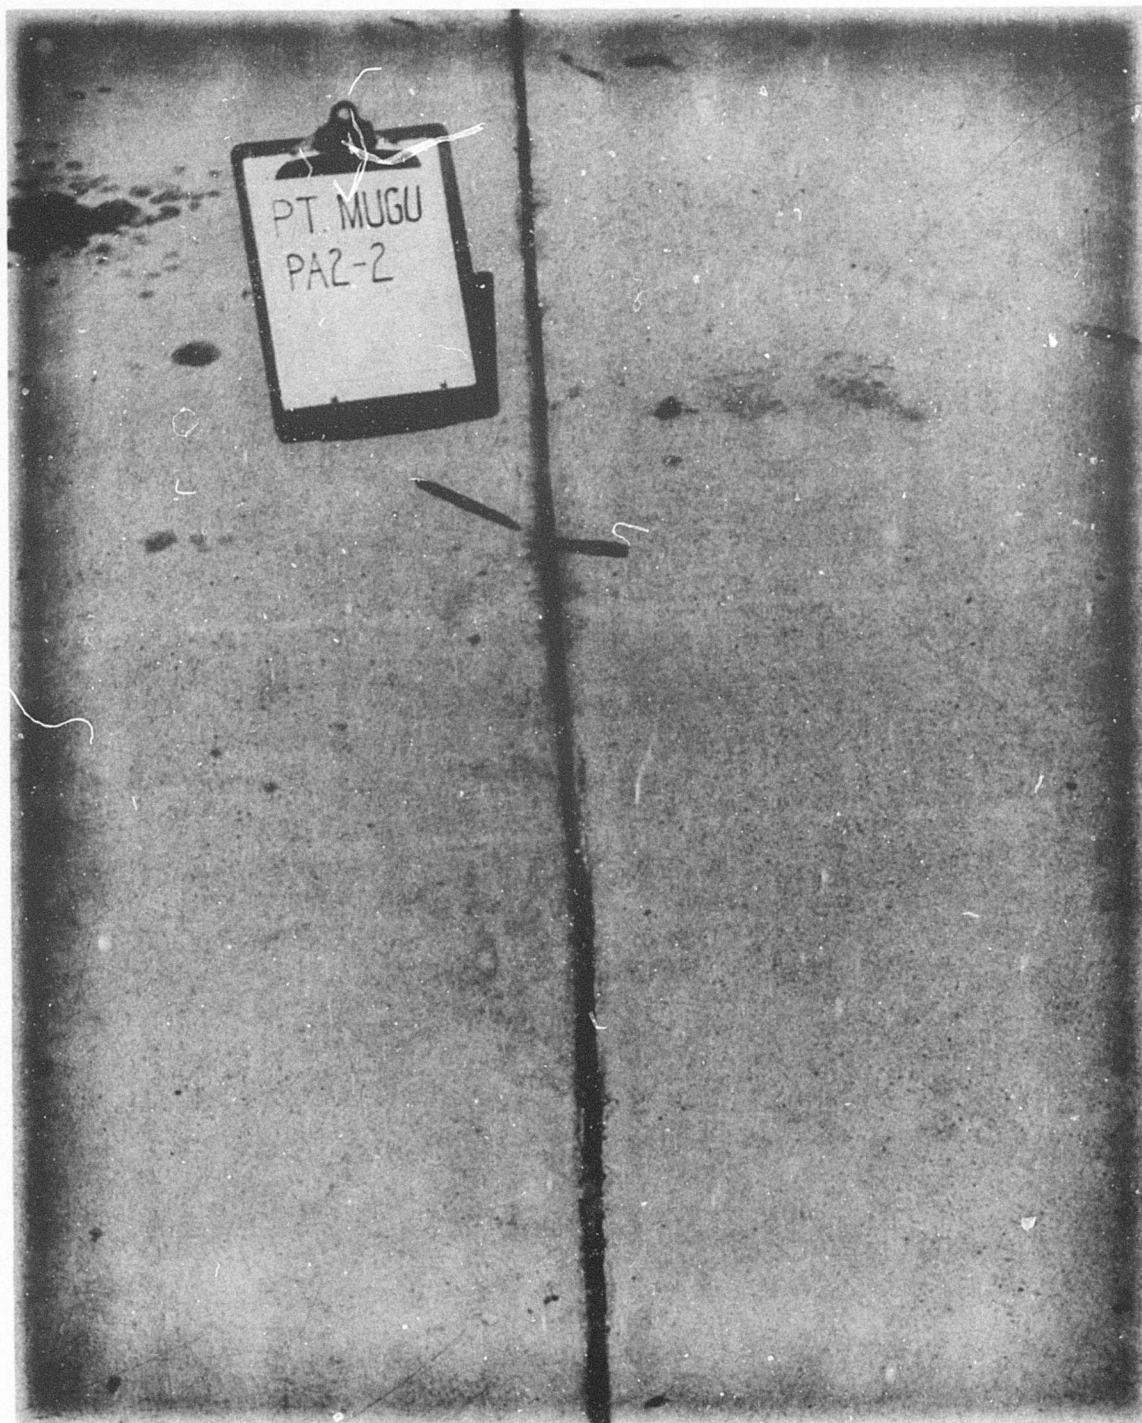
Figure 7. Missing joint seal, discrete area PA2-2.

Defect Type	No. of Sample Slabs w/Defect	Total Slabs w/Defect: c x a/b	Defect Density (per slab) d/a	Defect Severity Weight	Weighted Defect Density e x f
	(c)	(d)	(e)	(f)	(g)
Faulting					
Corner Break					
L.C. or T.C. *	4	16	0.067	1.0	0.07
I.C. **					
Depression					
Spalling	16	64	0.267	7.5	2.00
Scaling					
Shattered Slab					
Joint Seal	60	240	1.000	2.5	2.50
Pumping					
"D-line" cracking					
Remarks on Pavement Condition					Total 4.57C ***
Spalls were up to 3 inches wide. Joint seal had lost bond and was occasionally missing. See Figure 7.

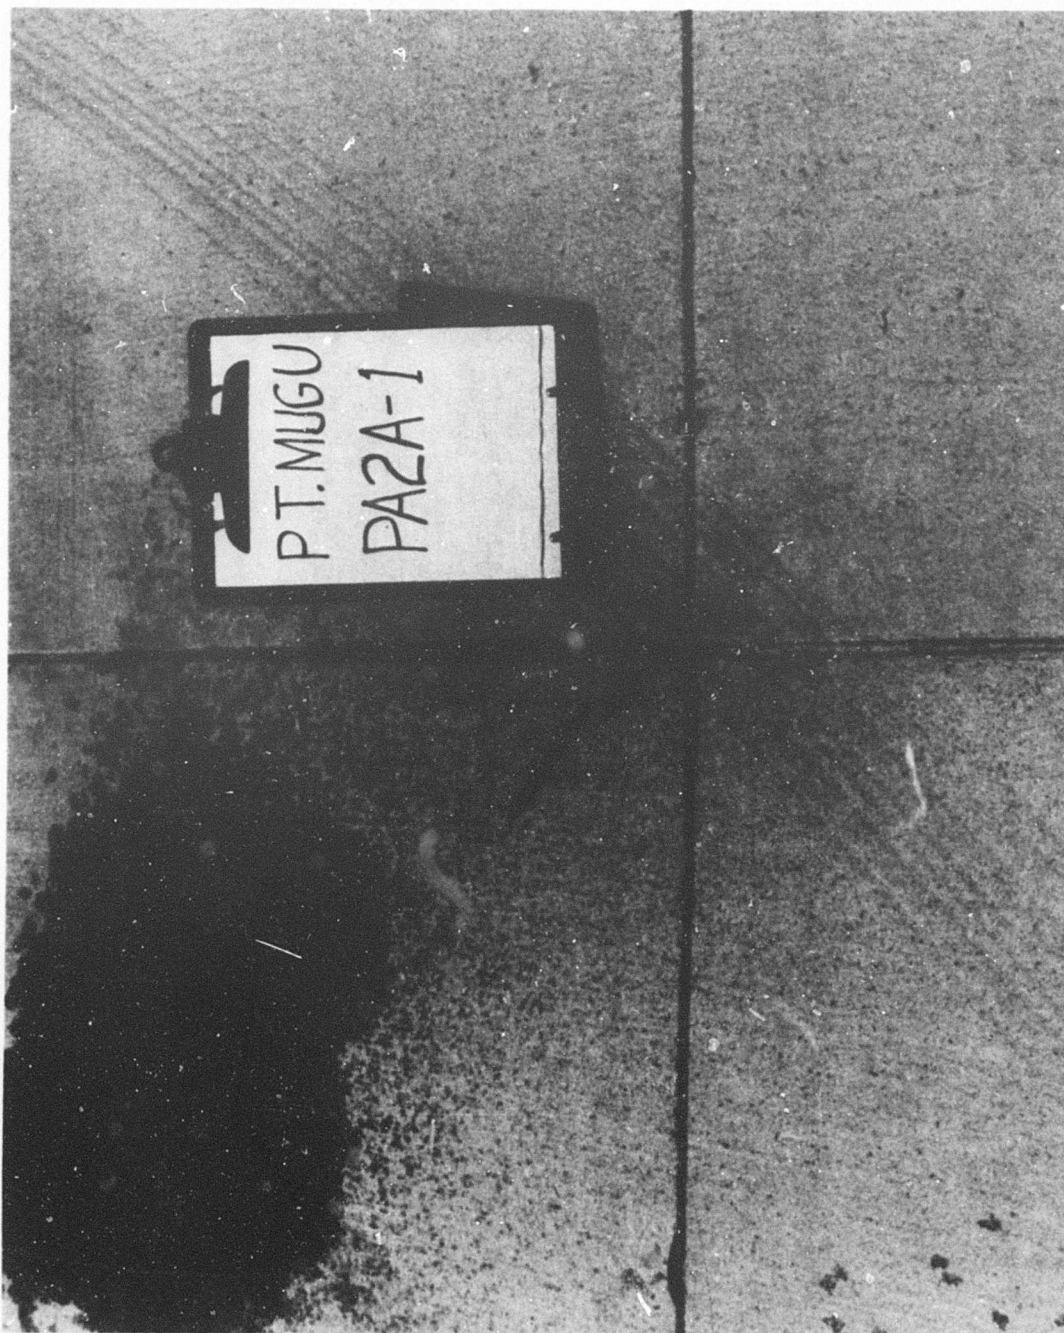
Figure 8. Missing and poorly bonded joint seal, discrete area PA2A-1.

Spalls were small, generally less than 1 inch wide and contained no loose material. Transverse cracks noted were unsealed. Joint seal had lost bond on one side of most joints. Occasionally the joint seal was missing. See Figure 8.

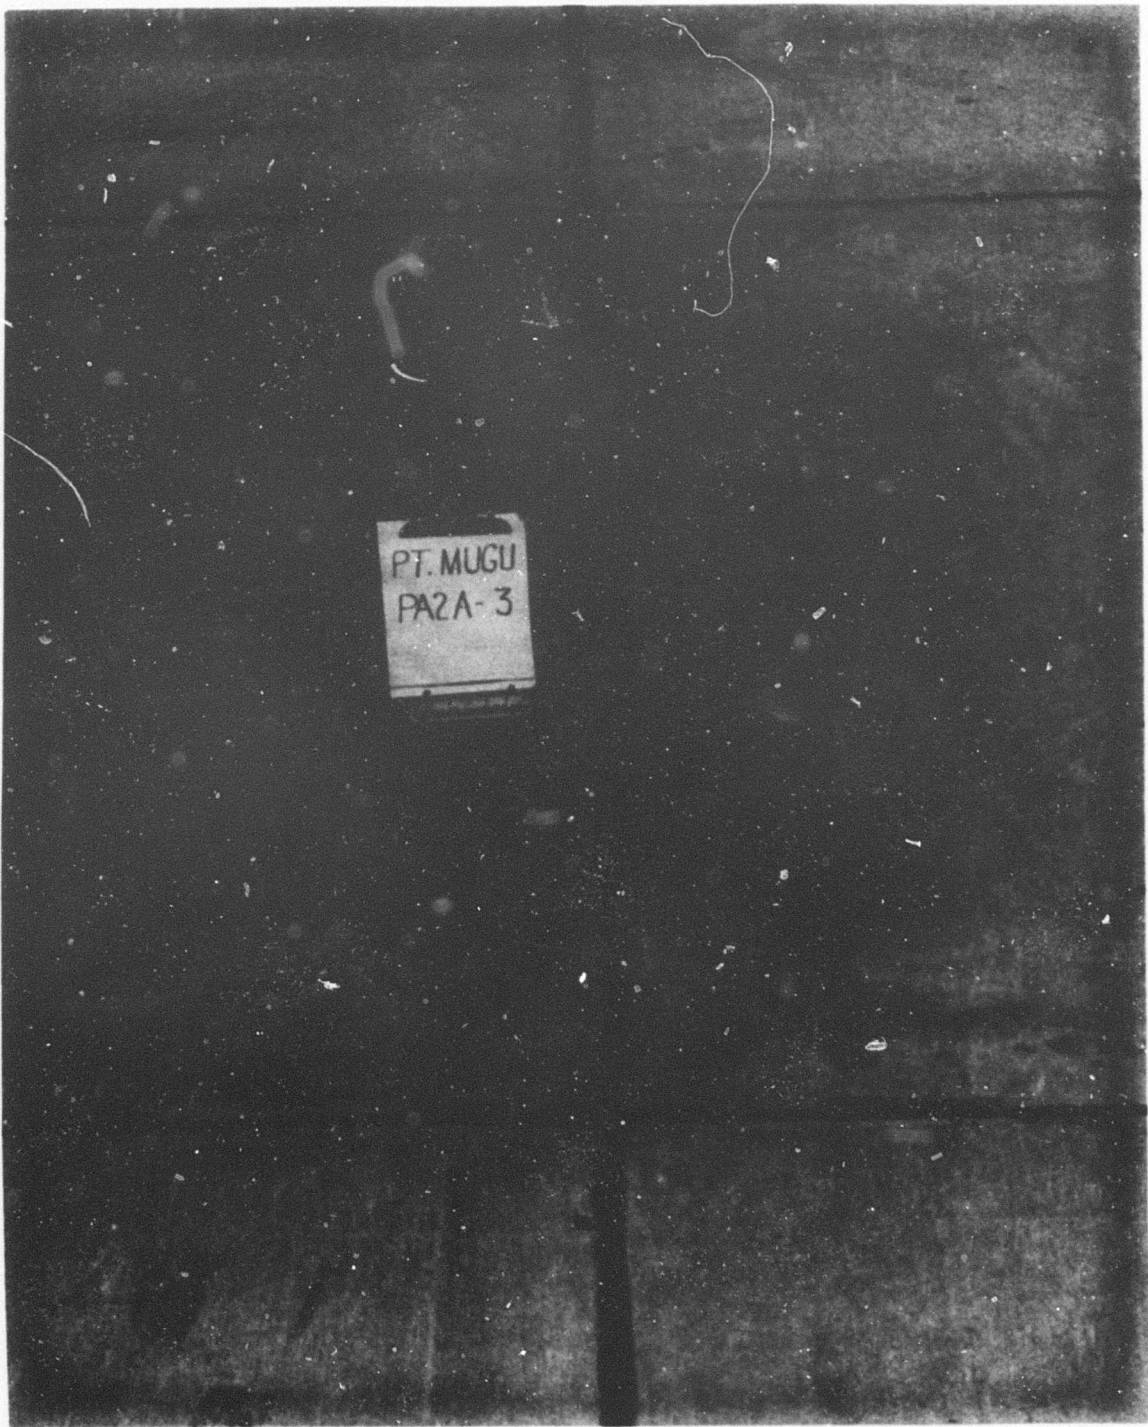
Figure 9. Severe joint spall, discrete area PA2A-3.

Joint seal was hardened and missing in many locations. Weeds were growing in some joints. Spalls were up to 6 inches wide and 10 feet long. See Figure 9.

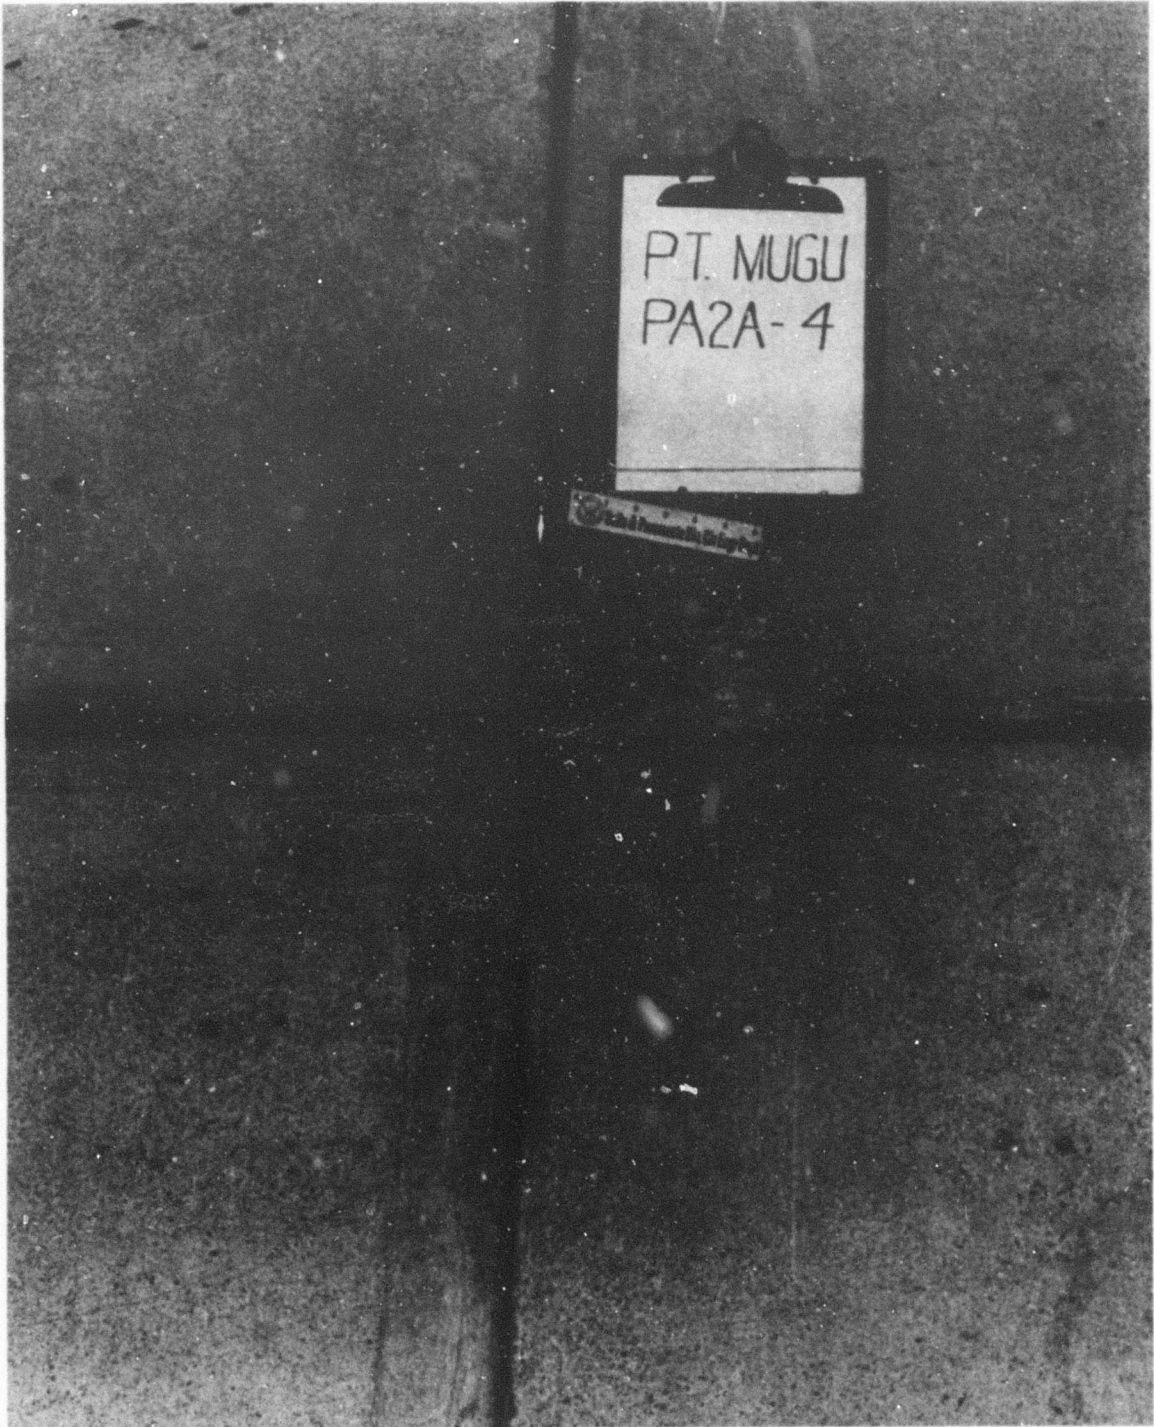
Figure 10. Severe corner spall and missing joint seal, discrete area PA2A-4.

Spalls ranged up to 6" wide and 8 feet long. Loose chunks were noted in most spalls. Joint seal was almost completely gone. See Figure 10.

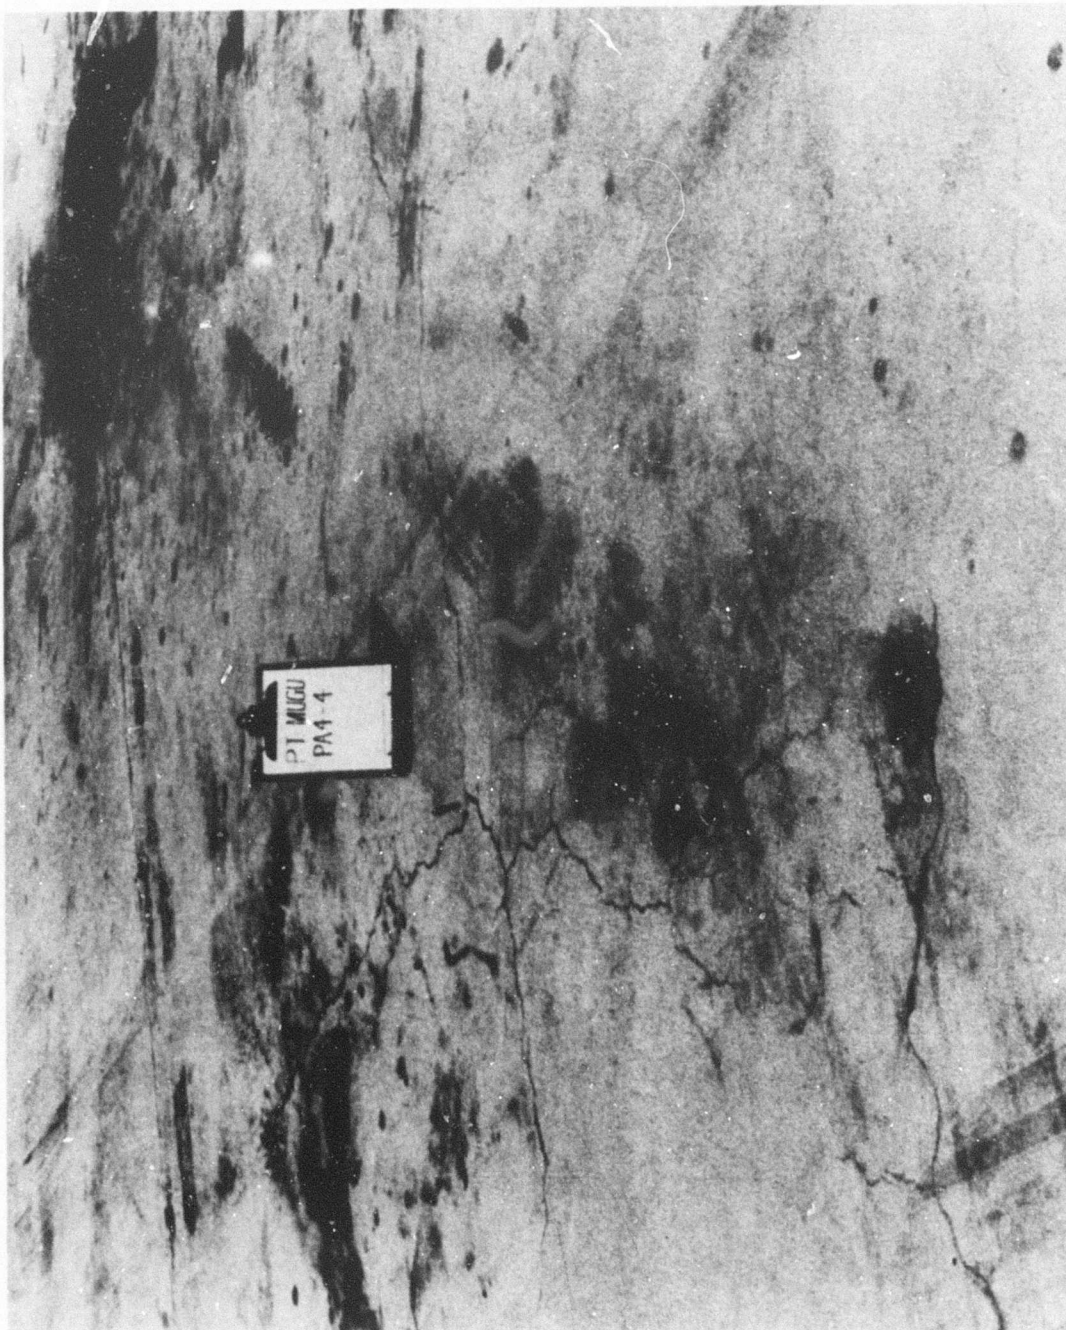
Figure 11. Shattered slabs, discrete area PA4-4.

Defect Type	No. of Sample Slabs w/Defect	Total Slabs w/Defect: c x a/b	Defect Density (per slab) d/a	Defect Severity Weight	Weighted Defect Density e x f
	(c)	(d)	(e)	(f)	(g)
Faulting					
Corner Break					
L.C. or T.C.*	10	10	0.667	1.0	0.67
I.C.**					
Depression					
Spalling	5	5	0.333	7.5	2.50
Scaling					
Shattered Slab	4	4	0.267	9.0	2.40
Joint Seal	15	15	1.000	2.5	2.50
Pumping					
"D-line" cracking					
Remarks on Pavement Condition_____Total					8.07C...
The 60' x 60' slabs had cracked into several pieces. All cracks were unsealed. Spalls were up to 6 inches wide. See Figure 11.

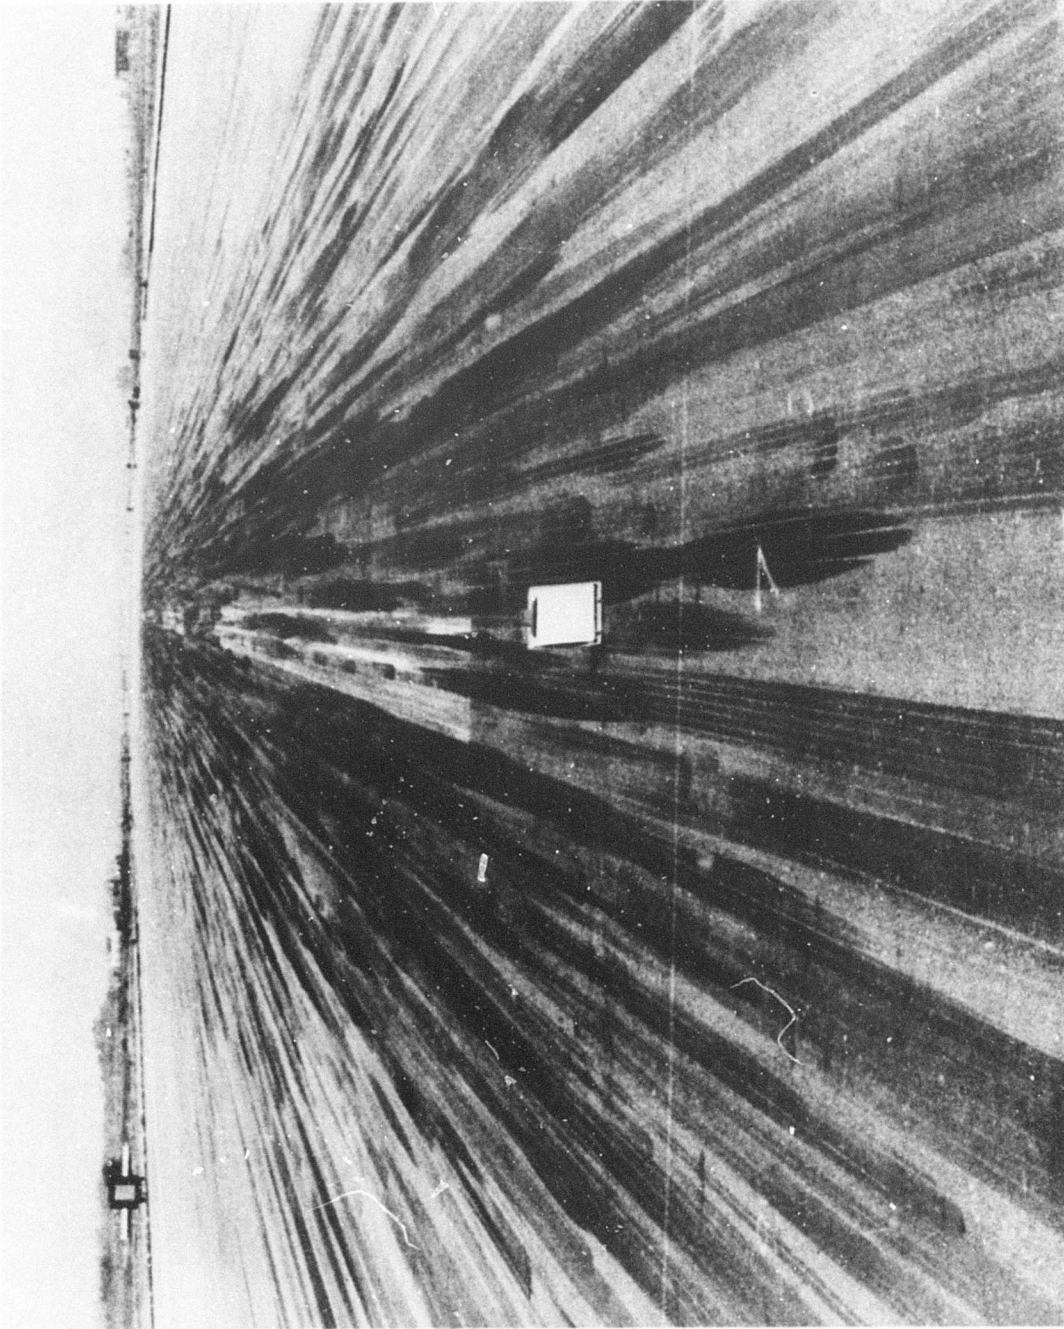
Figure 12. General view showing the excellent condition of discrete area R3-1.

Defect Type	Length or Area of Sampled Defects	Total Length or Area of All Defects (c) x Ratio	Defect Density (per 10 sq ft) 10 d/a	Defect Severity Weight	Weighted Defect Density (e) x (f)
	(c)	(d)	(e)	(f)	(g)
T.C., L.C. or LCJ*					
Reflection Crack					
Faulting					
Patching					
Settlement or Depression					
Pattern Cracking					
Rutting					
Raveling					
Erosion - Jet Blast					
Oil Spillage					
Broken-up Area					
Total					0.00A
Remarks on Pavement Condition					
The surface aggregate of the 1967 overlay was just beginning to become exposed. No measurable defects were found. See Figure 12.

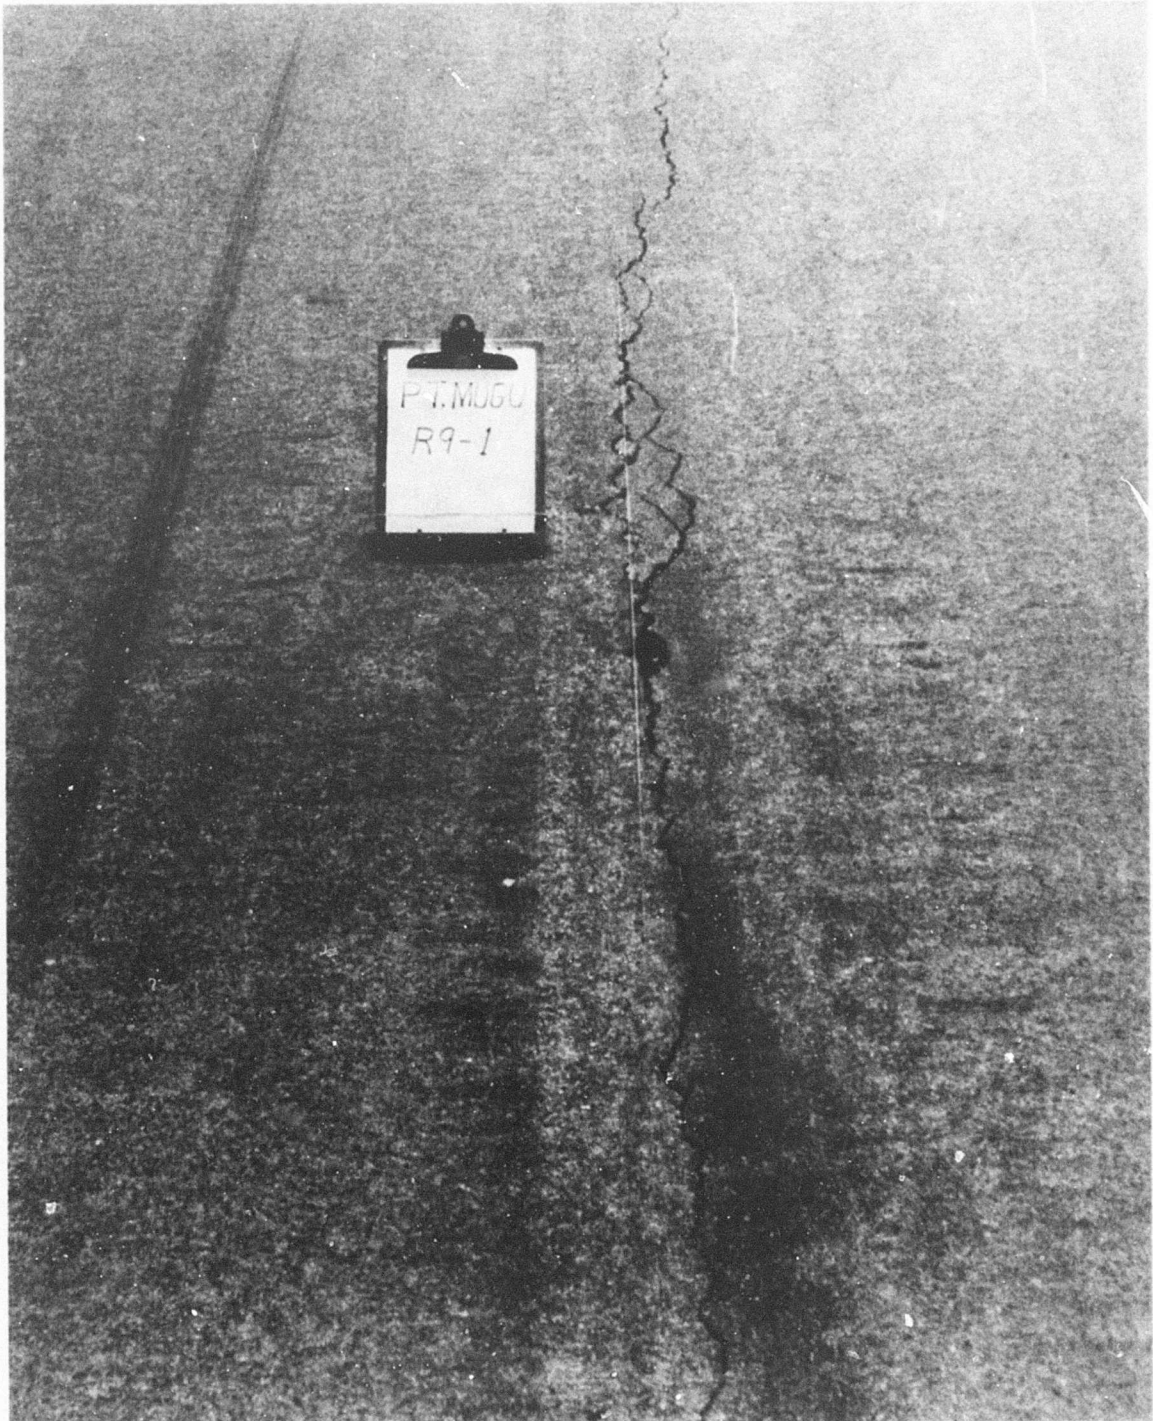
Figure 13. Unsealed longitudinal construction joint crack, discrete area R9-1.

Defect Type	Length or Area of Sampled Defects	Total Length or Area of All Defects (c) x Ratio	Defect Density (per 10 sq. ft.) 10 d/a	Defect Severity Weight	Weighted Defect Density: (e) x (f)
	(c)	(d)	(e)	(f)	(g)
T.C., L.C. or LCJ*	495 ft.	5940 ft.	0.132	2.5	0.33
Reflection Crack					
Faulting					
Patching					
Settlement or Depression					
Pattern Cracking	1107 ft. <sup>2</sup>	13284 ft. <sup>2</sup>	0.296	2.5	0.74
Rutting					
Raveling					
Erosion-Jet Blast					
Oil Spillage					
Broken-up Area					
Total					1.07A
<p align="center"><b>Remarks on Pavement Condition</b></p> <p>The pattern cracking was less than 1/16 inch wide and appeared to be shrinkage cracks. Longitudinal construction joint cracks were open to a maximum width of 1/8 inch. See Figure 13.</p>

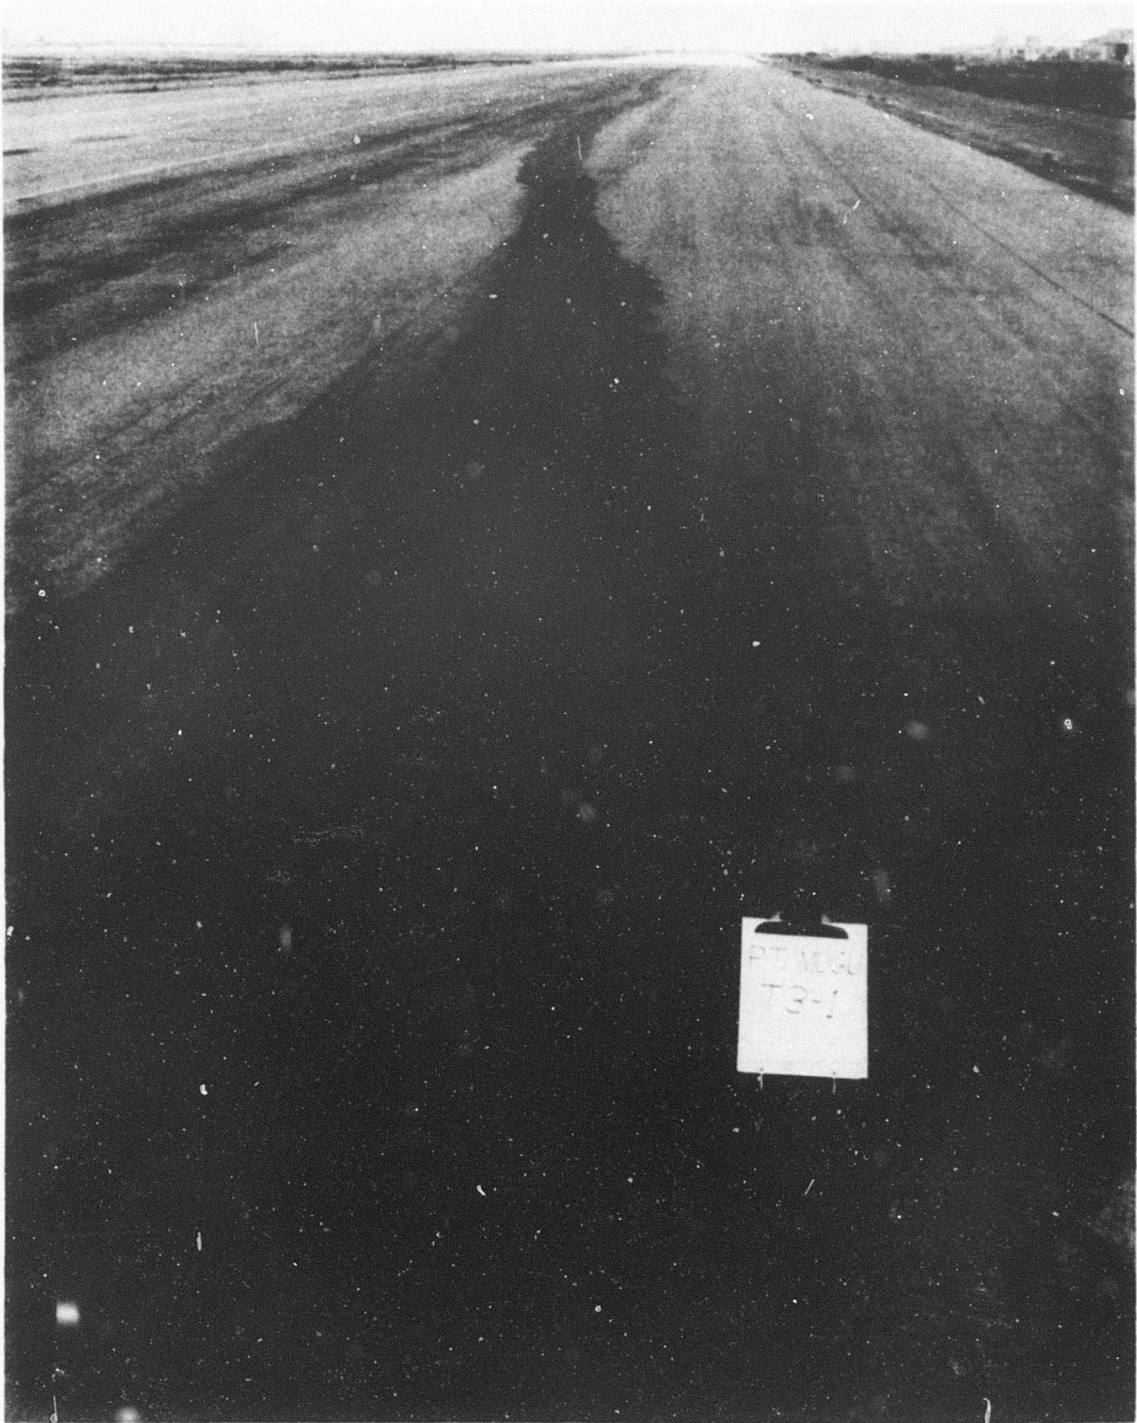
Figure 14. View of oil or fuel spillage, discrete area T3-1.

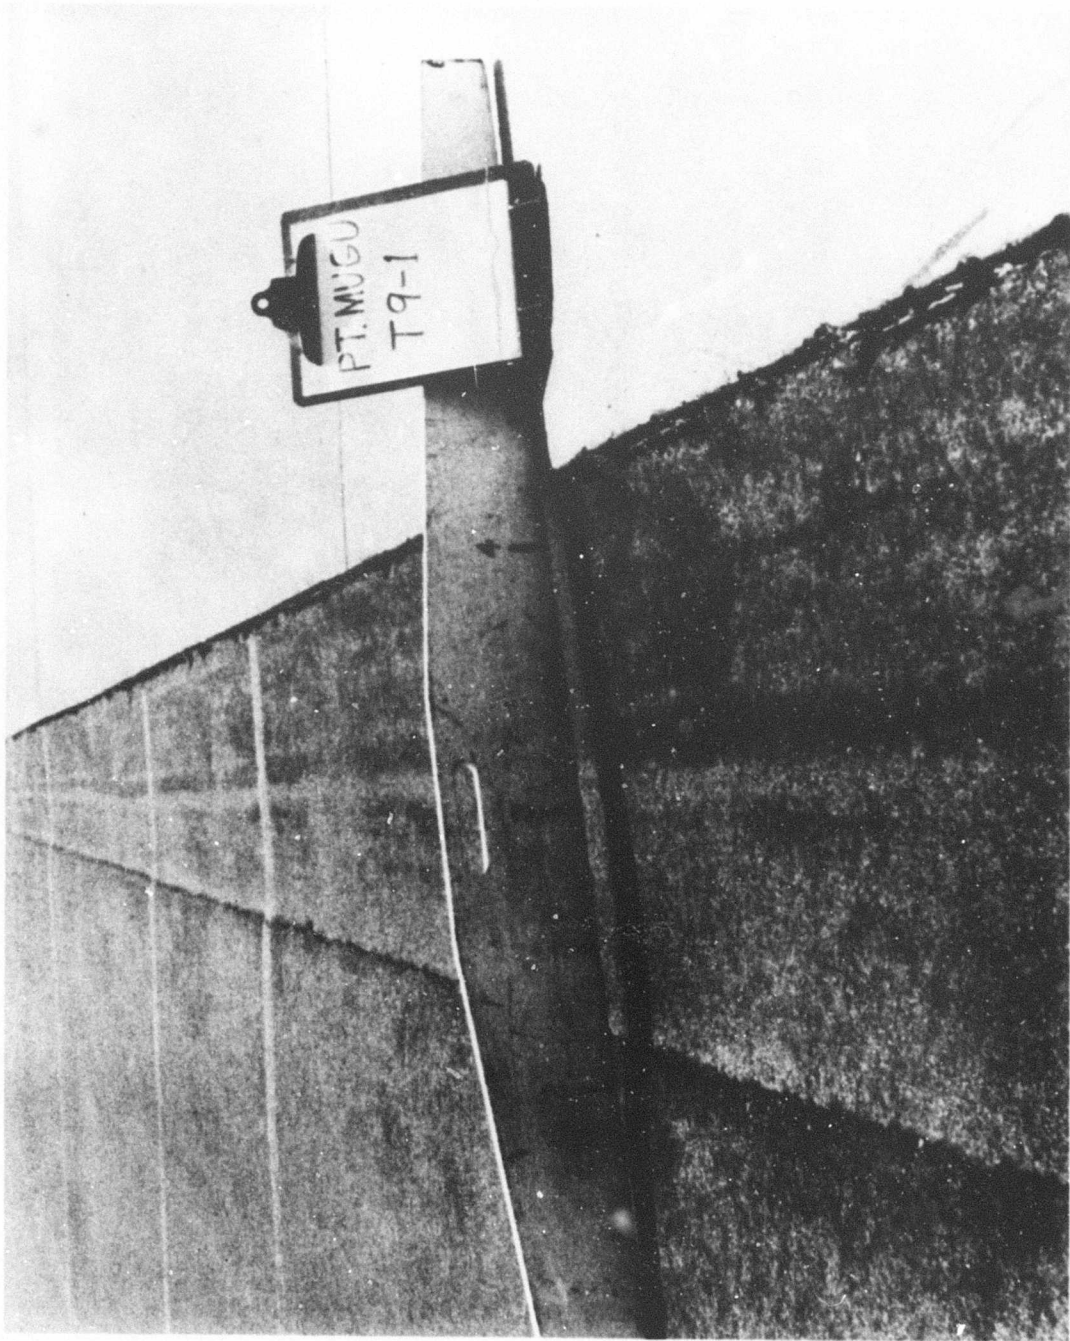
Figure 15. Faulting along taxiway edge, discrete area T9-1.

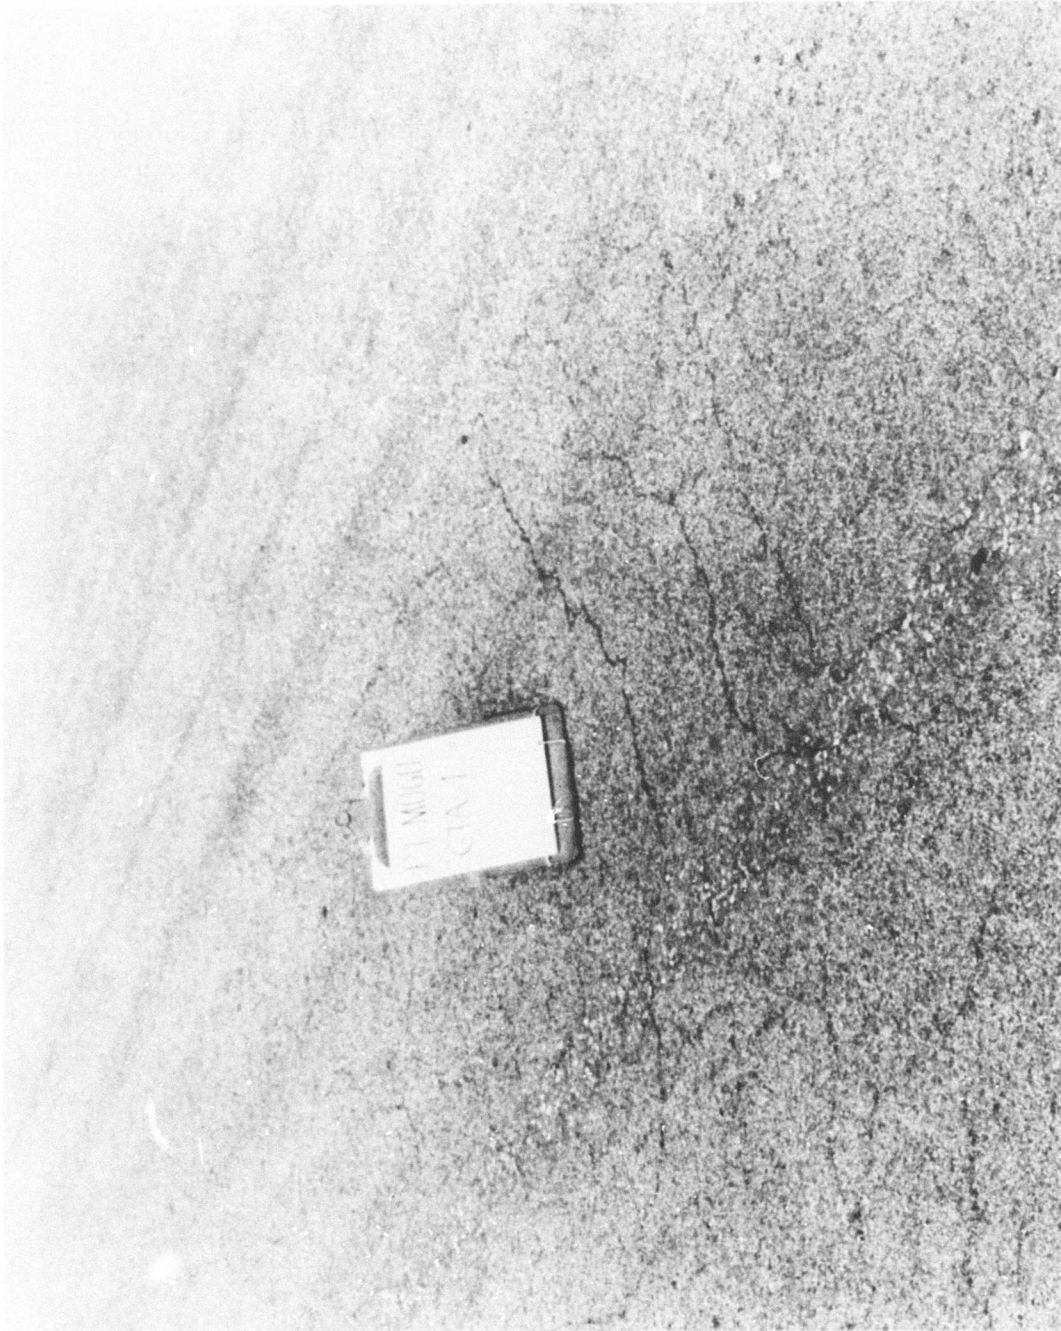
Figure 16. Pattern cracking, discrete area CTA-1.

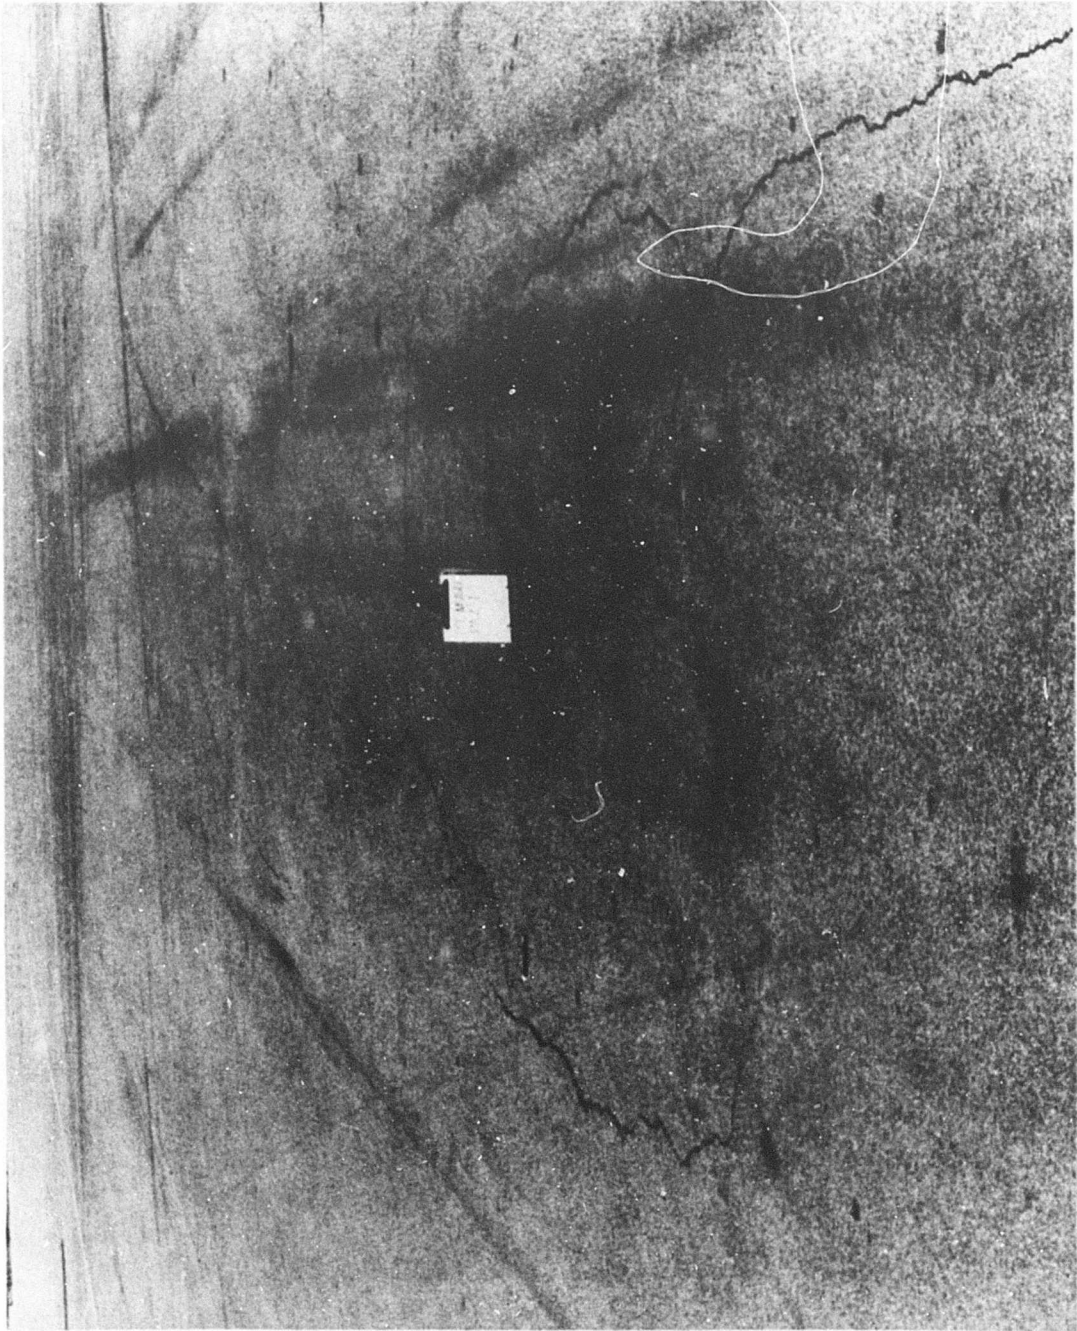
Figure 17. Longitudinal and transverse cracks, discrete area PA2-1.

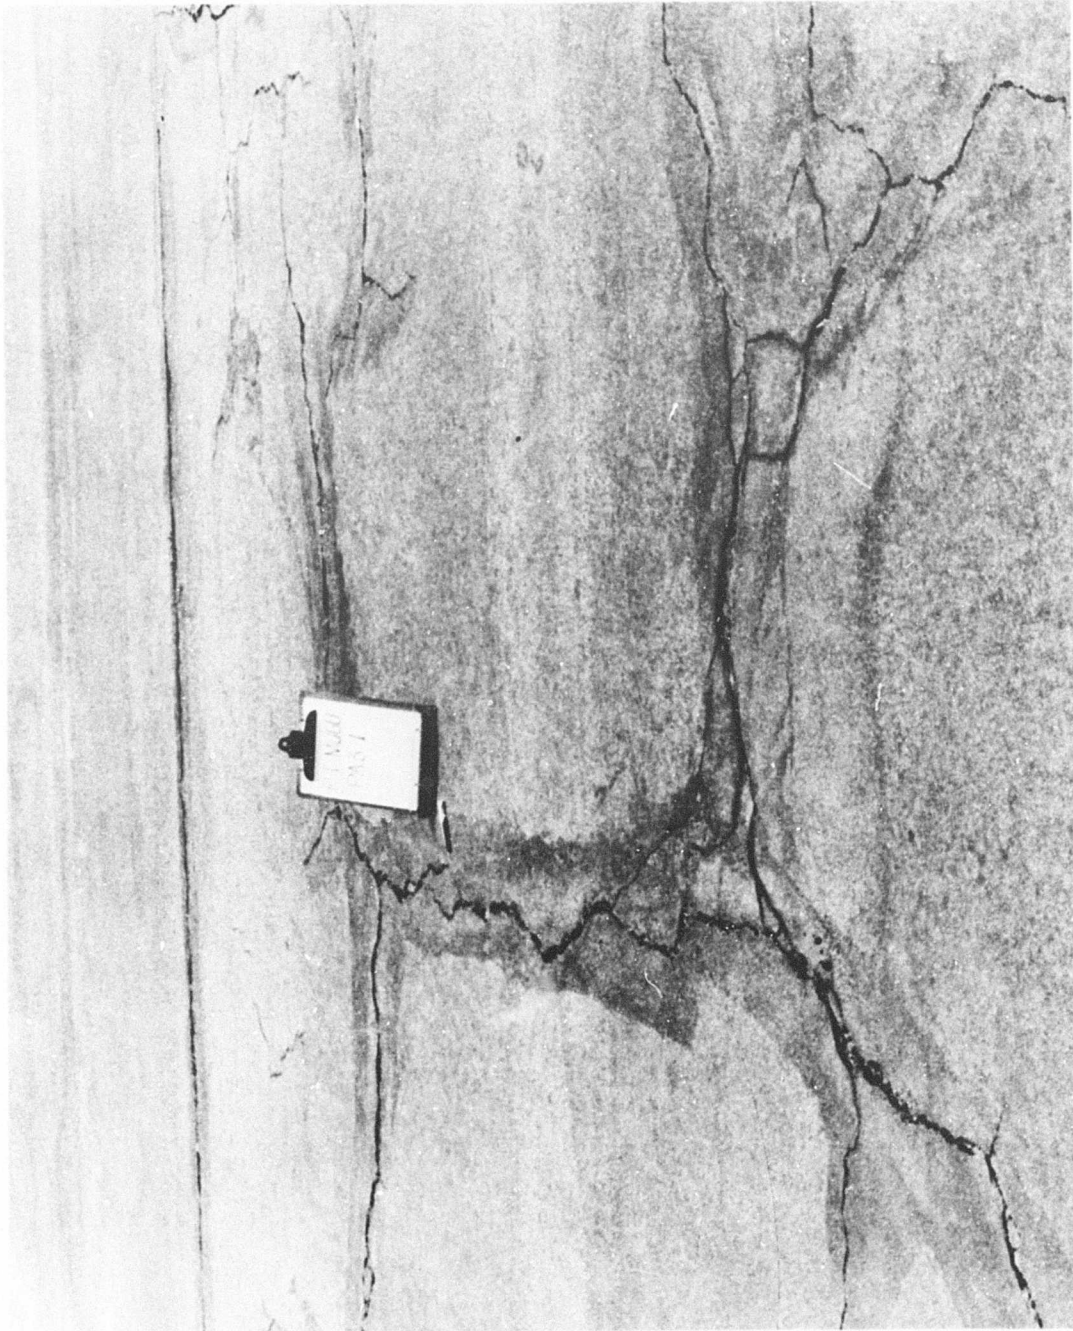
Figure 18. Pattern cracking, discrete area PA3-1.
